**BIG-BOX RETAIL CENTER  
RETENTION POND RESTORATION  
AUGUSTA, GEORGIA**

2019 CASE STUDY

# MOSQUITO INFESTATION LEADS TO SHORELINE RESTORATION, ENVIRONMENTAL REPAIRS

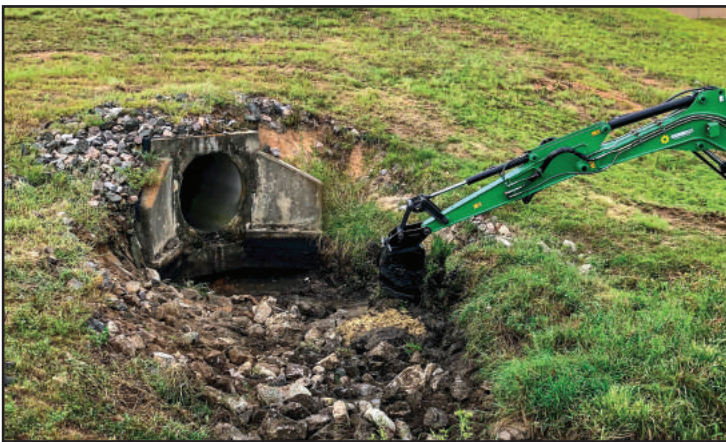
Big-box out flow culvert pipe is damaged from years of high capacity storm water run off.

DredgeSOX stabilized the hillside adjacent to the culvert. This secured the land and prevented torrents of water from damaging the repaired cement culvert. The SOX reinforcement mat was also installed under water at the mouth of the culvert to further stabilize the bottom. Several tons of rocks were loaded onto the mesh to strengthen the pond bottom and enhance water flow out of the culvert.

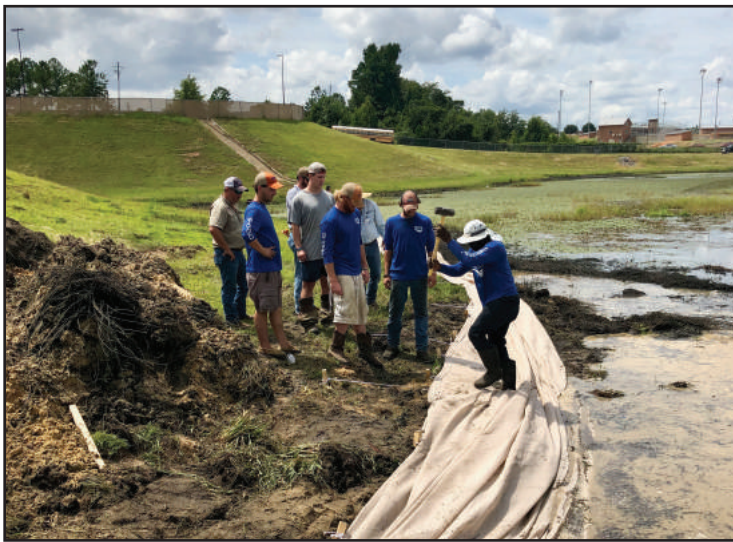
The SOX material is laid out and the staking system is pounded in place.

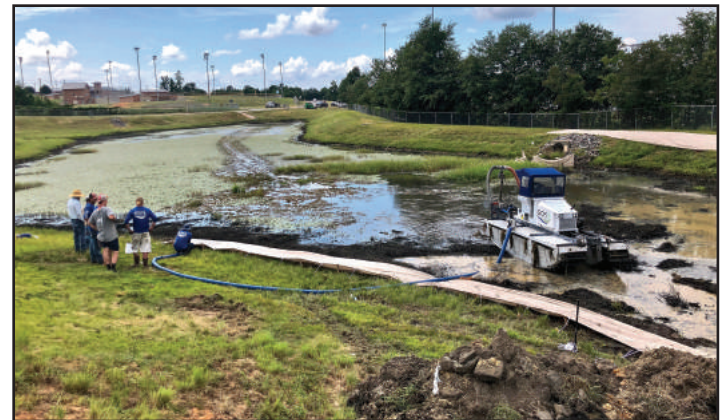
Using an amphibious work boat, pond sediment is dredged into the SOX system to stabilize the shoreline.

The shoreline restoration started with the installation of DredgeSOX, a long-lasting and eco-friendly erosion-control technology. It is also an effective way to remove sediment from waterways and reclaim shorelines that complies with all Best Management Practices of "Living Shoreline" restorations.

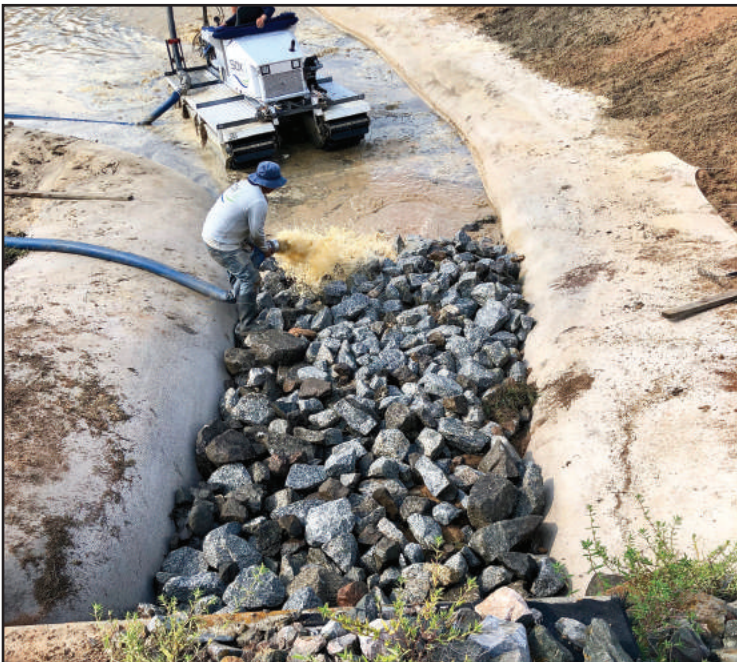
A combination of dredged sediment and excess fill from the project fills the SOX system and then secured by pound the staking system subsurface.

Once filled with sediment, the DredgeSOX material is secured to the shoreline. Sod and other landscaping is planted and then roots through the knitted mesh, creating a long-lasting, living shoreline.
